Reference: Quarterly Progress Report  
Consent Agreement and Final Order (CAFO)  
Docket No. RCRA-05-2014-0013  
Project No. 242933.0000

**PROGRESS REPORT – First Quarter 2016**  
**Canton Drop Forge, Inc.**  
**Canton, Ohio**  
**U.S. EPA ID No. OHD00446S142**

Canton Drop Forge – February 1 and 5, 2016  
Pond 2 Closure Removal

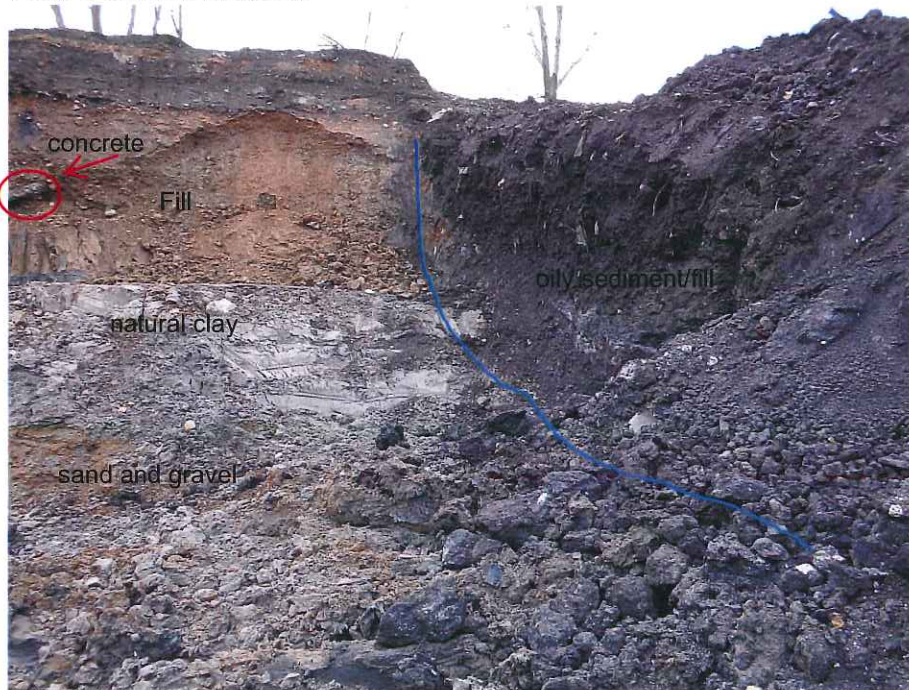
Photo 1: Contact of oily sediment at right with clay layer overlain by sand and gravel fill with intermixed ash/slag/soil fill near surface

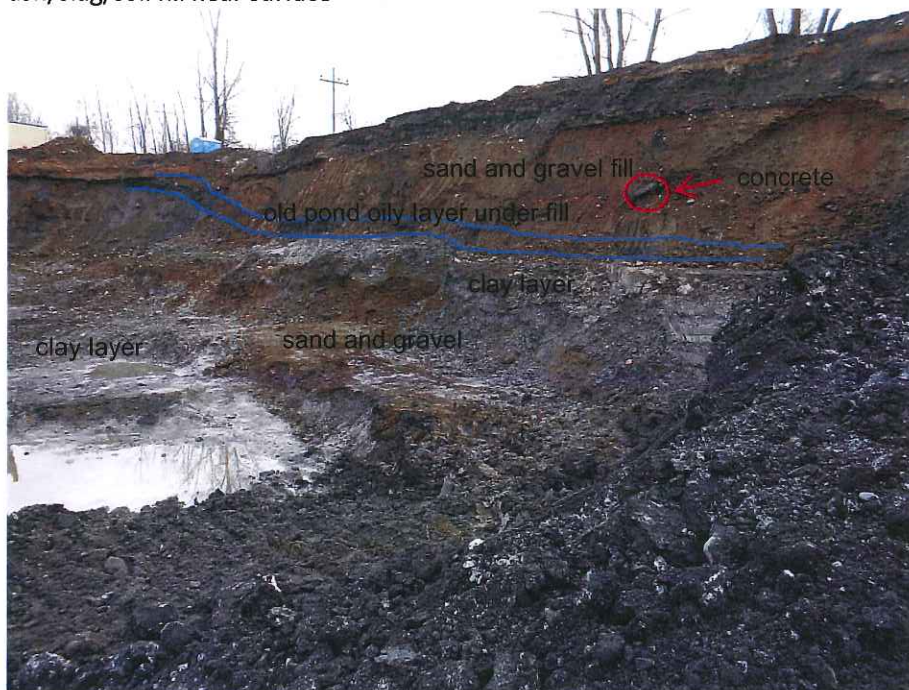
Photo 2: Panorama of above photo. Oily material at right being removed. Removal complete in background.

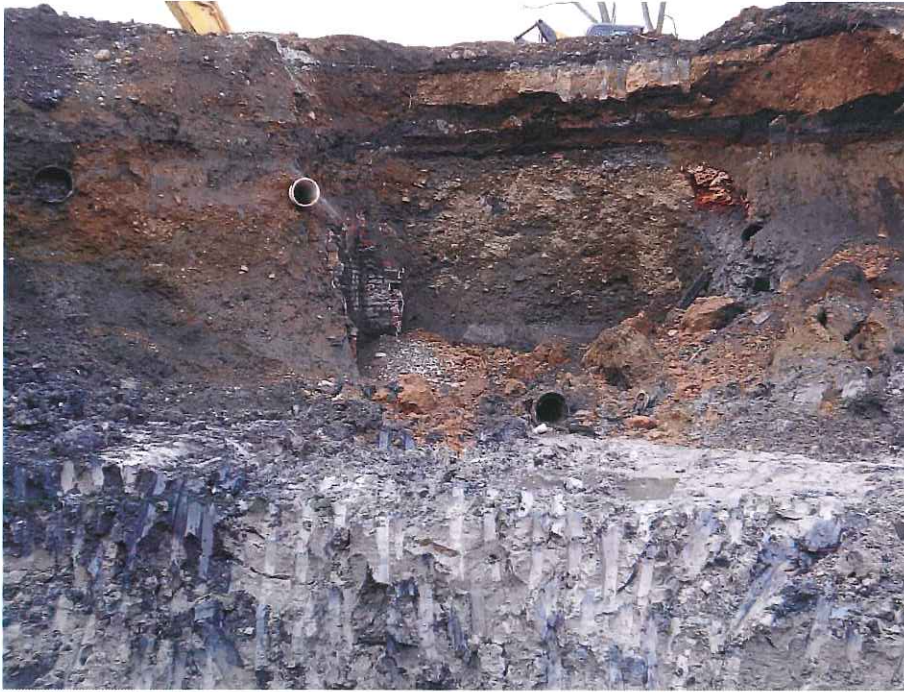
Photo 3: View of SW corner. Brick structure believed to have been former pumphouse approx. 12 ft. bgs. All pipes to be plugged except new stormceptor pipe (white PVC). Lowest pipe is fallen tile.

As noted above, an abandoned brick structure was encountered below grade on the west end of Pond No. 2. As this structure became uncovered, additional pipes on either side of the structure were also identified. The unknown pipes appeared to be filled with impacted material and further investigation was necessary to determine how to properly address these structures. Photos are provided in Attachment 1.

Review of a drawing from 1994 (provided in Attachment 5) shows three pipelines entering Pond No. 2; one of the lines appears to be a storm drain coming from Southway Street (that was previously capped with concrete at the street). After additional soil removal, the pipe located below the new stormceptor line and the line on the north side discontinued. Additional photos are provided in Attachment 1. It was concluded that these pipes were remaining pipe stubs from the abandoned structure just removed. These extra pipes on the West side were cleaned out to the extent possible and filled with concrete. There was no sign of the storm drain line from the street. The remaining storm drain line connects to the stormceptor which now drains into Pond No. 2 at a location just south of the old removed drain that originated at the street.

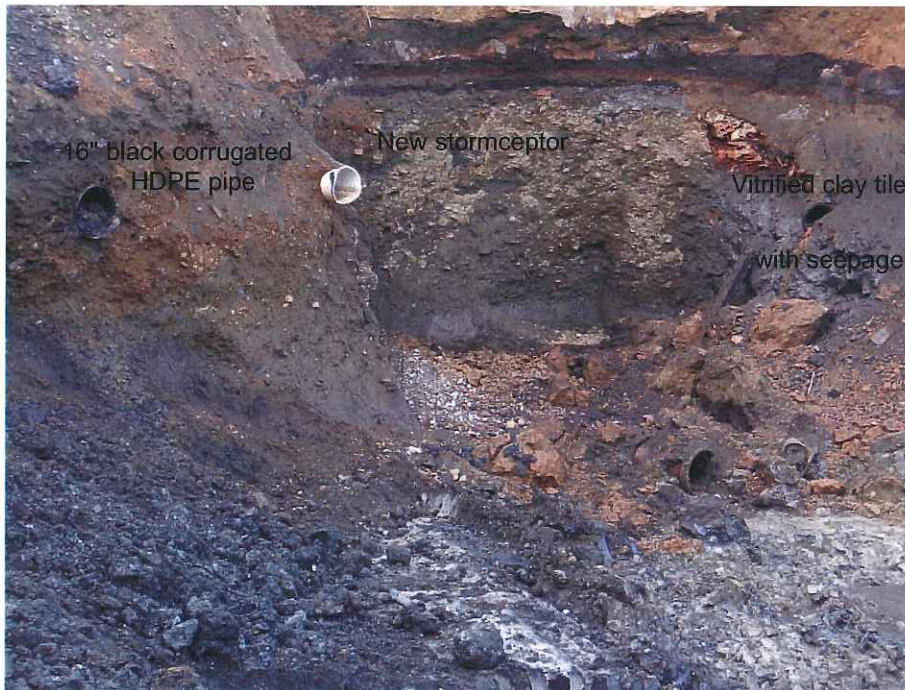
Photo 4: Close up of photo 3.

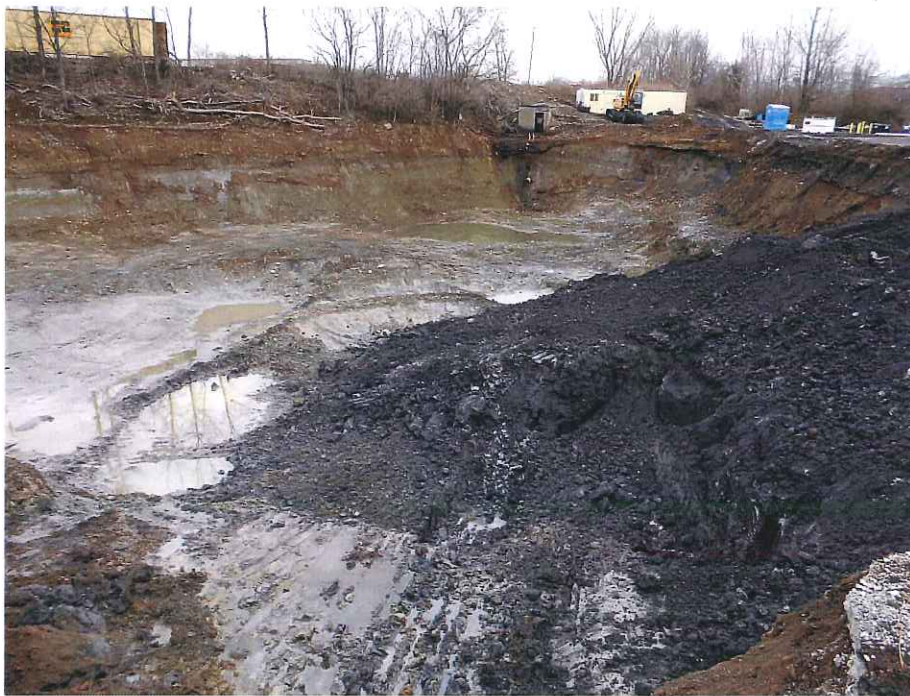
Photo 5: View on 2/1/2016. Dark solidified oily material being removed on right.

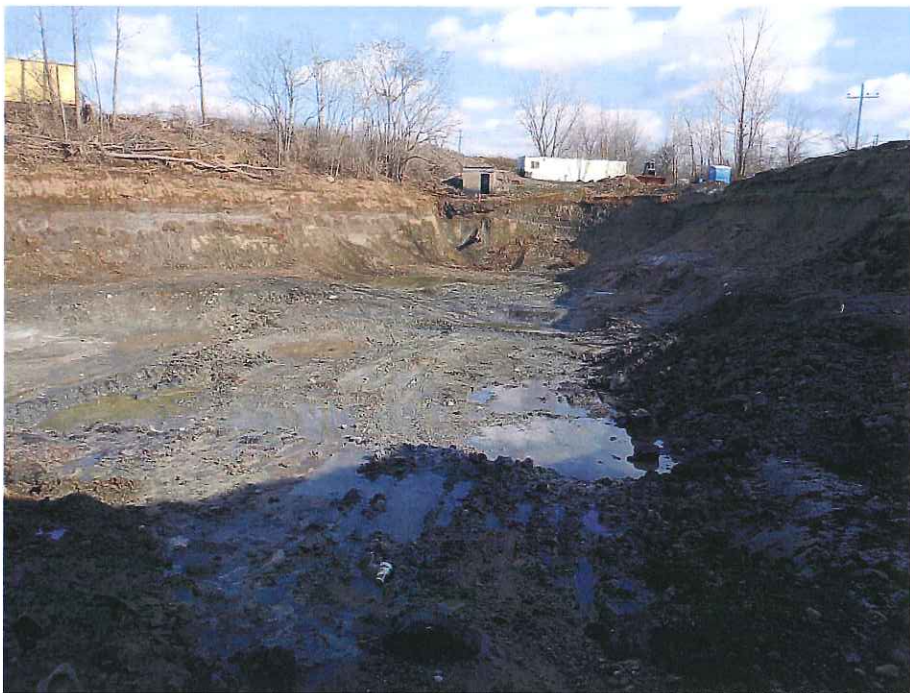
Photo 6: View as above on 2/5/2016. Removal of solidified oily material on right nearly complete.

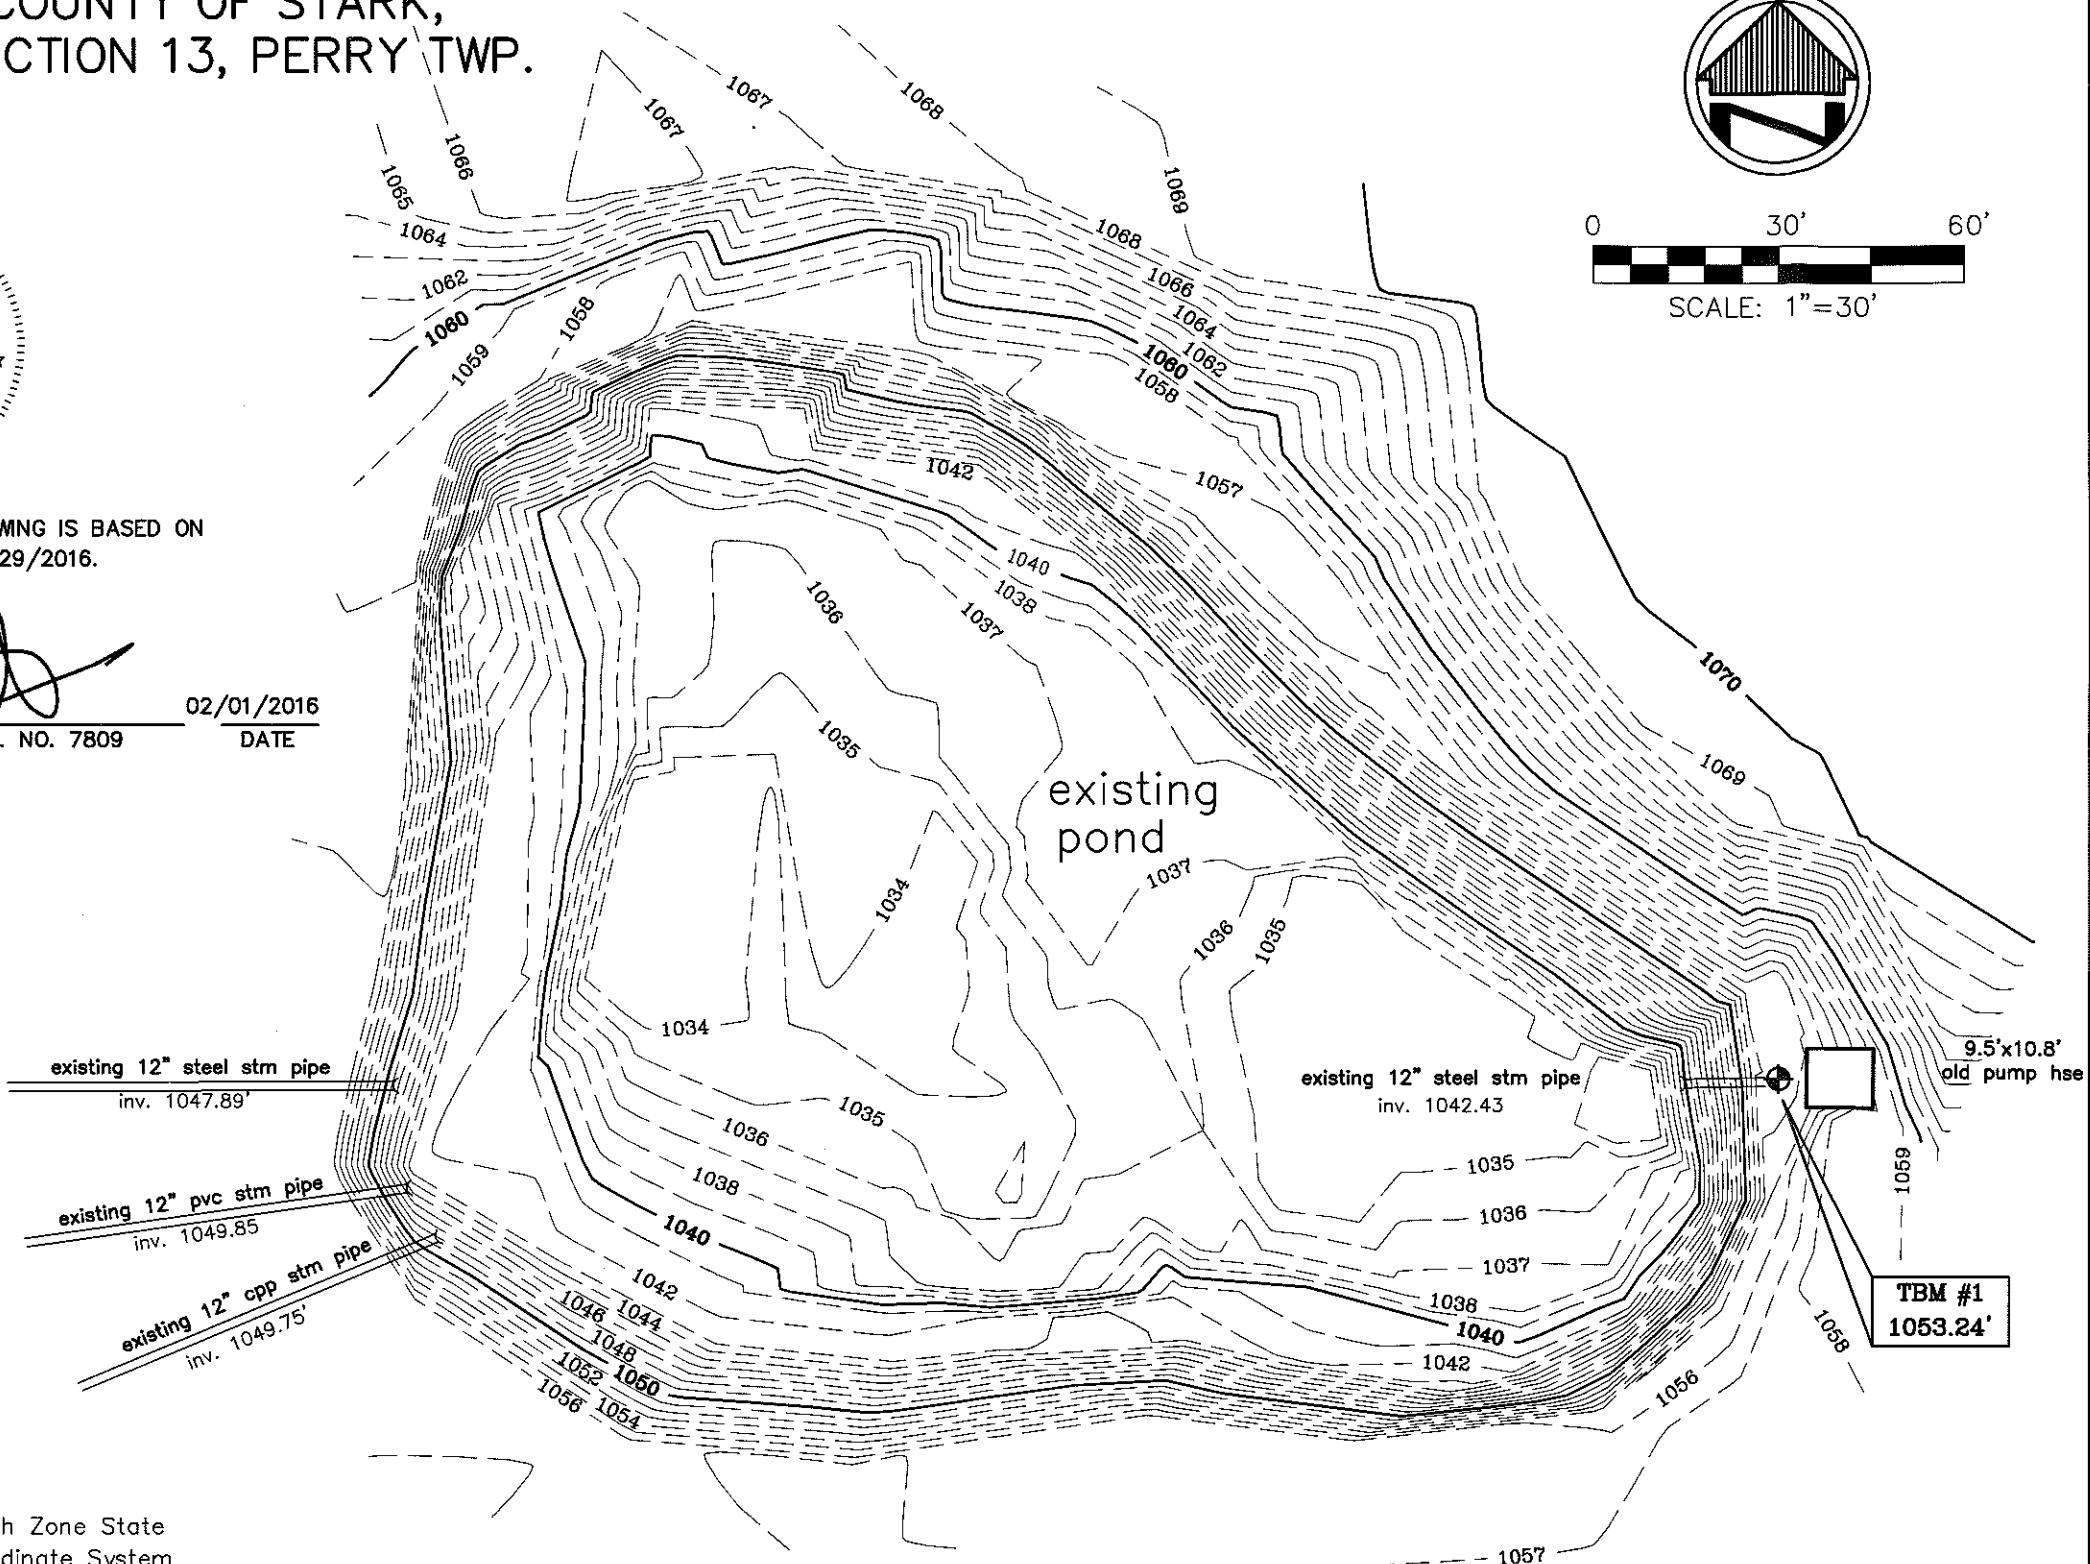
PHASE No. 2 POND AS-BUILT  
CANTON DROP FORGE  
4575 SOUTHWAY STREET S.W.  
CANTON, OHIO

I HEREBY CERTIFY THAT THIS DRAWING IS BASED ON  
ACTUAL FIELD CONDITIONS ON 01/29/2016.

The survey of the pond unit following the removal activities (dated 1/29/2016) is provided in Attachment 3.
